(19)
THE EFFECTIVENESS OF A SEDIMENT AND EROSION CONTROL
ORDINANCE: RICHLAND COUNTY, SOUTH CAROLINA

Submitted in Partial Fulfillment of the
Requirements for the Degree of Master of Science
in the Department of Geography
University of South Carolina

1991

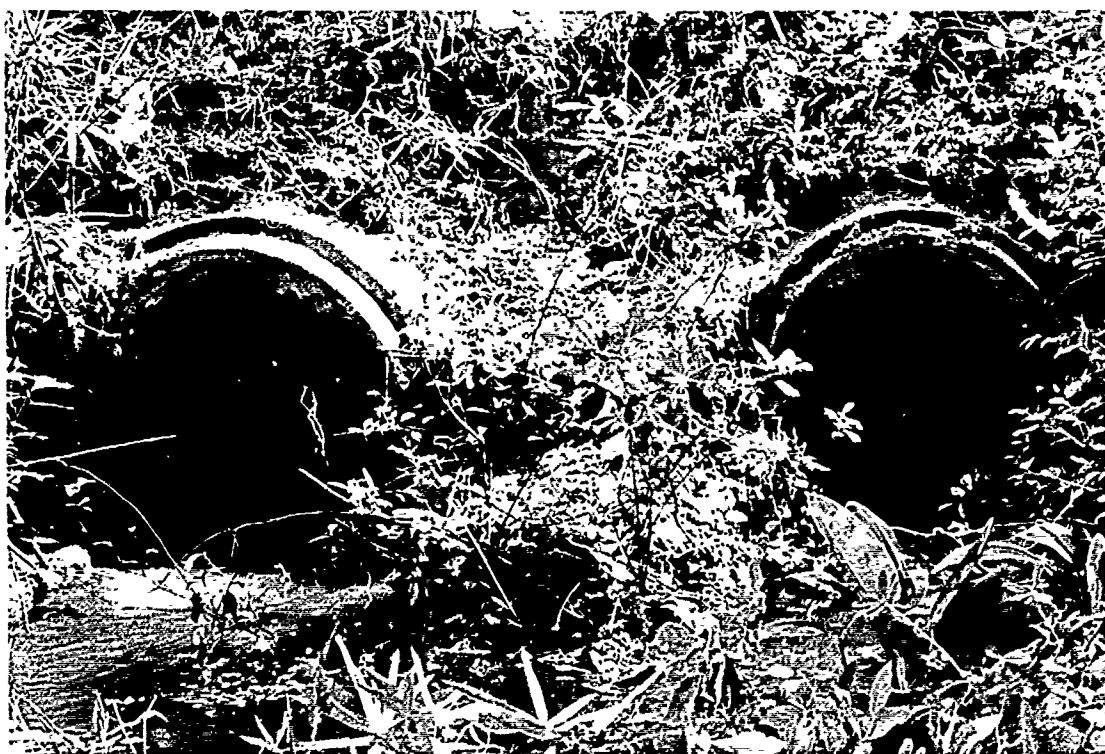
Photo 1-1 Downstream section of 30" and 36" concrete pipes.

southerly direction for 7,000 feet (2,133 m) to Clemson Road (Figure 1-3). At Clemson Road, Winslow Creek drains the basin through a pair of concrete pipes approximately 30" and 36" in diameter (Photo 1-1).

downstream sections of the 30" and 36" concrete pipes (Figure 2-3 and Photo 1-1). This site was selected on the basis of its accessibility under high-water and adverse conditions and the ability to accurately estimate stream velocity and discharge at the pipes. Adverse effects of this sample site include a tendency for slack-water sedimentation upstream of the pipes and delivery of sediment from road side sources. These complications were unavoidable given the limitations of this project.

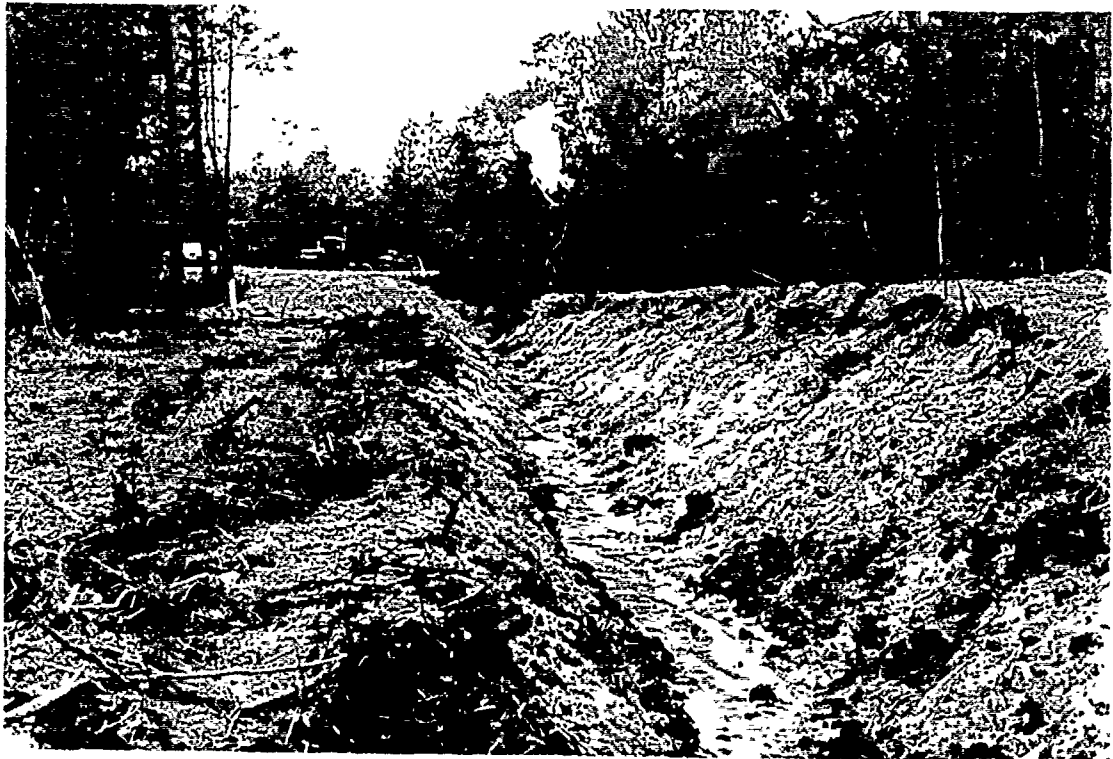
Photo 1-2 Upstream view of Moss Field Creek. Channel improvements include deepening and widening of channel.

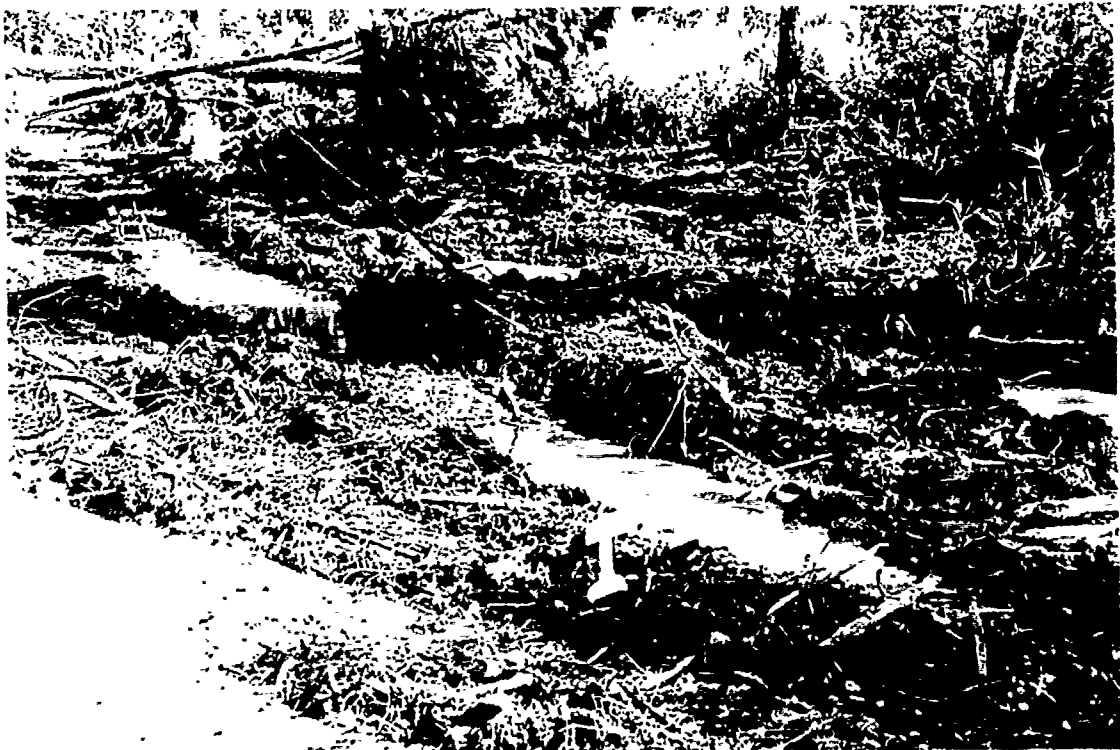
Photo 1-3 Typical Johnston Loam stripped of protective vegetation. Note standing water one-week after storm.

The Johnston (Jo) series are deep, very poorly drained soils that form in loamy fluvial and marine sediment (Lawrence, 1978) (Photo 1-3). These soils are found along stream channels and within the flood plain of the basin.

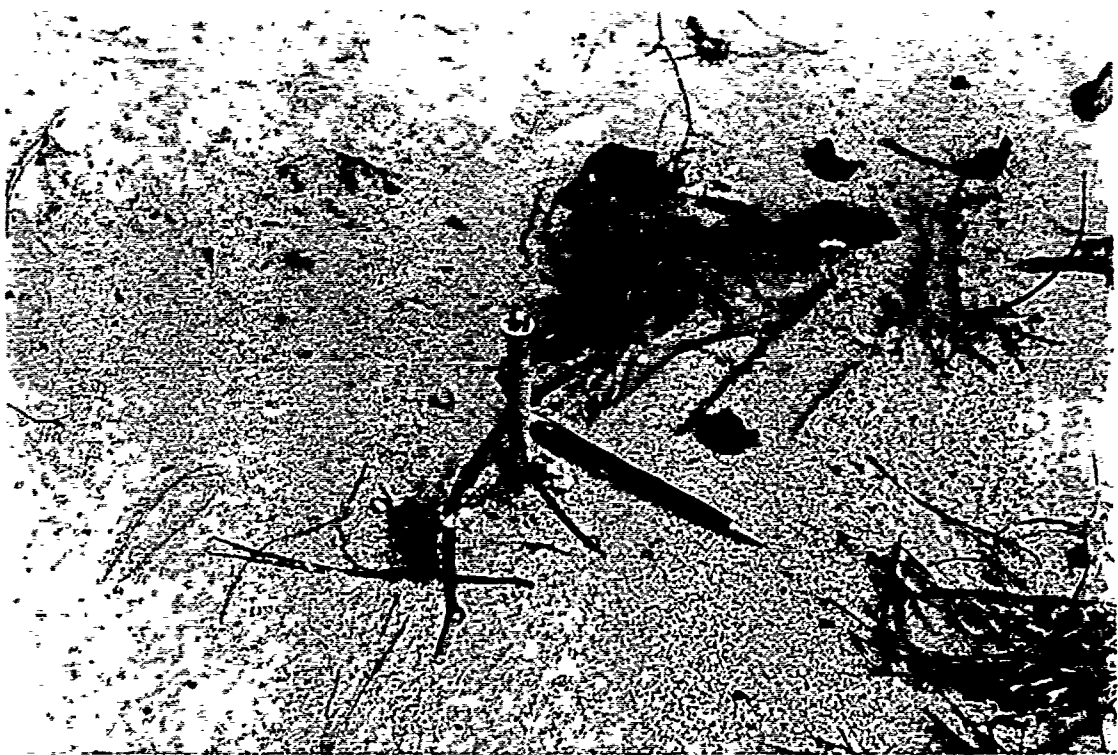
Photo 2-3 10" galvanized nail used as an erosion pin. Pin penetrates half its length to measure deposition.

As an independent check of erosion rates, erosion pins were placed in select areas in the drainage basin to measure soil erosion and deposition rates. The erosion pins are 10" galvanized nails with a washer fitted loosely around the stem of the nail to act as a guide for measuring soil erosion (Photo 2-3). They were placed at either the crest, mid-slope, or toe of a slope and marked with a red survey flag for identification purposes. The erosion pins at the crest of the slopes were driven into the soil until the washer came into contact with the soil. The erosion pins placed at mid-slope or toe positions, were driven only half way into the soil and the exposed portion of the nail was used to measure rates of deposition. Siting of the erosion pins was limited to channel bank slopes, freshly graded soil, and selected housing plots. Movement of heavy construction equipment throughout the site did not permit a thorough coverage in the basin. Several of the pins were vandalized or damaged by construction activity.

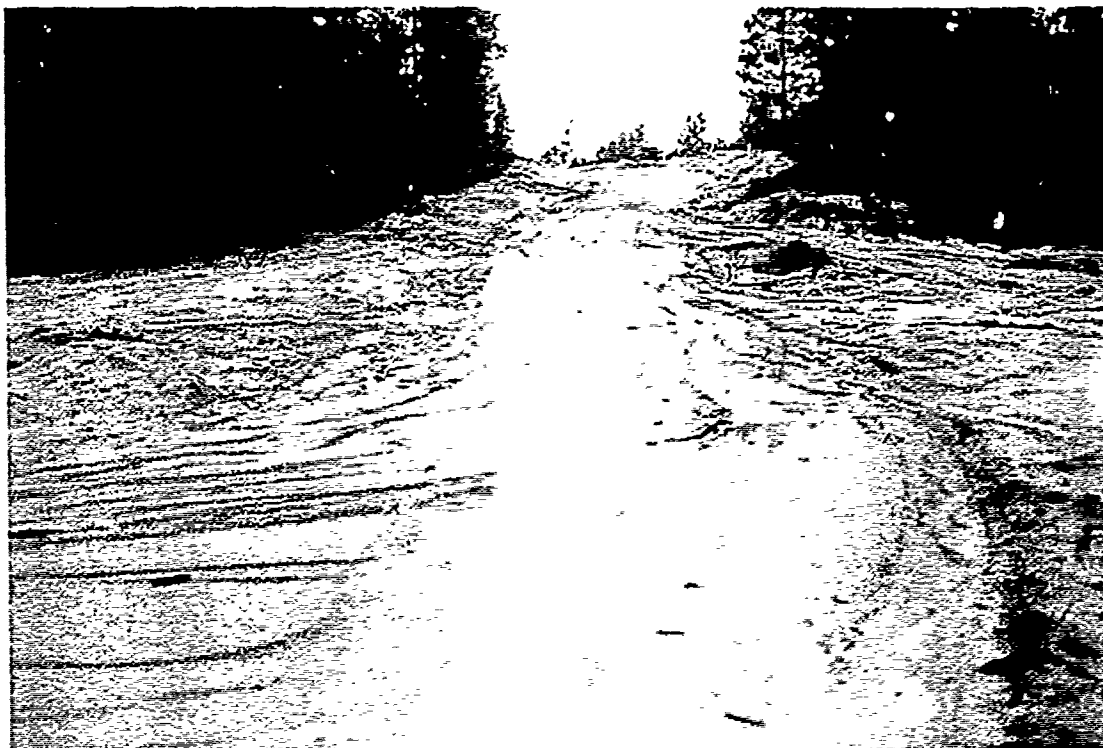
Photo 3-1 View up Winslow Way road cut, October 10, 1990. Sediment is transported directly into channel.

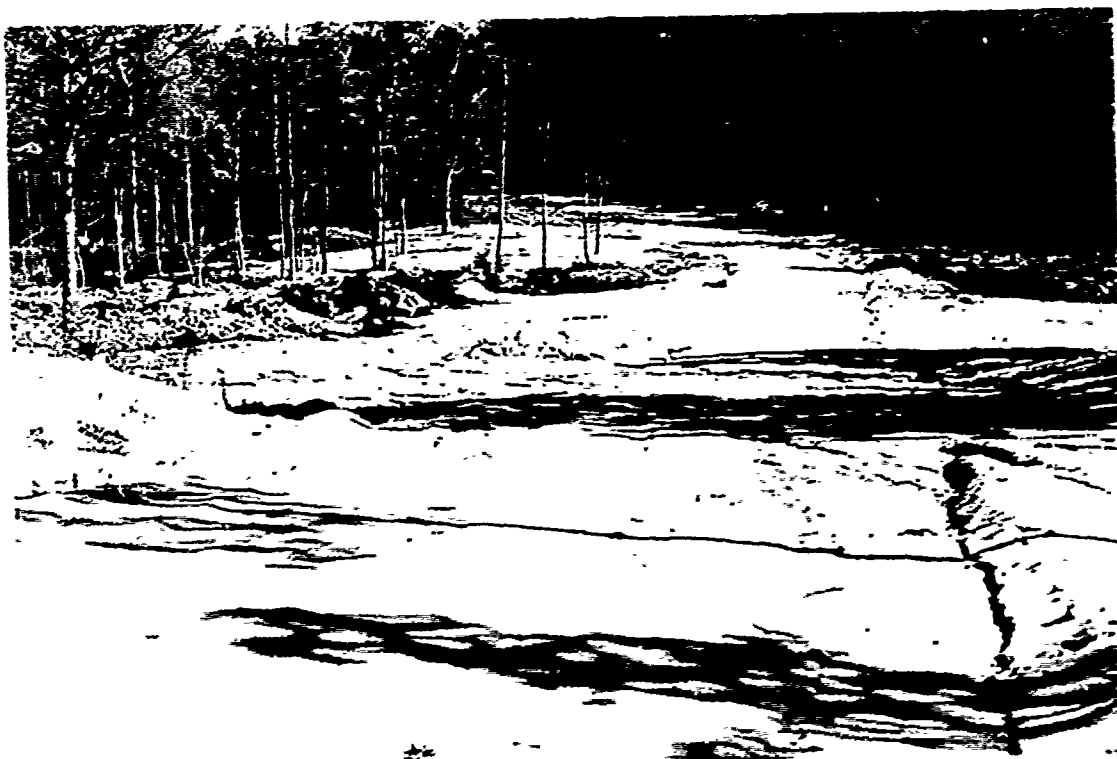
Photo 3-2 View down Winslow Way road cut. Winslow Creek in middle foreground flowing left to right.

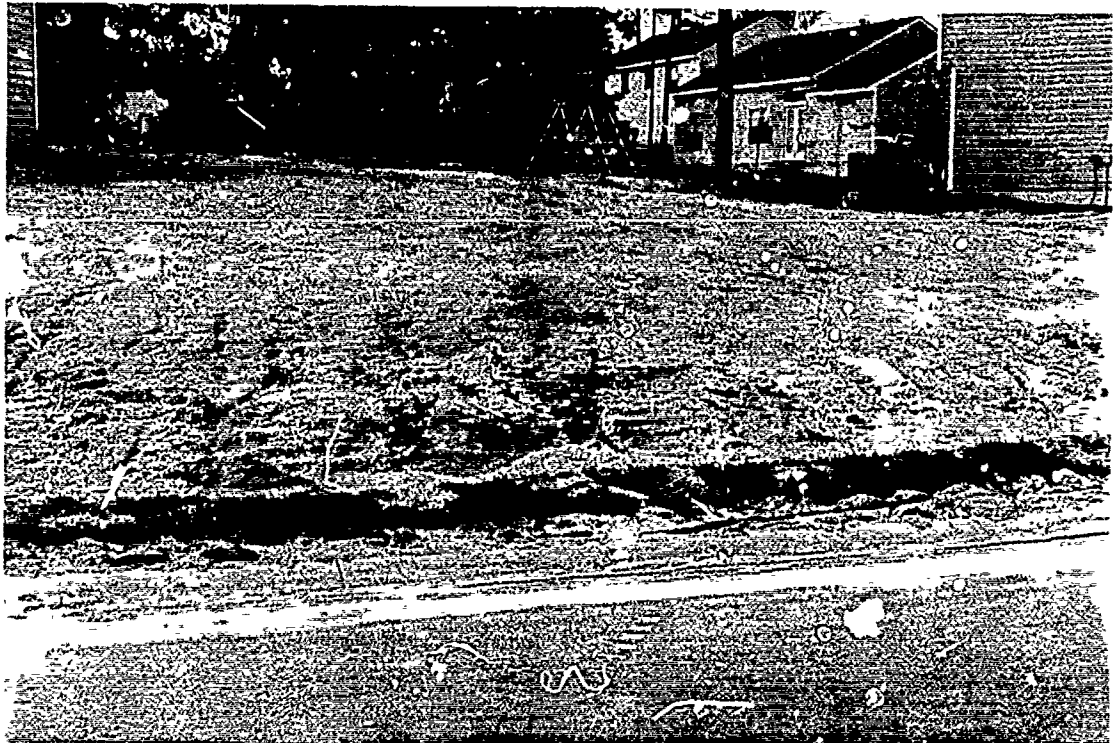
Photo 3-3 Unvegetated homesite in subdivision. Notice rills and sediment collecting in the street.

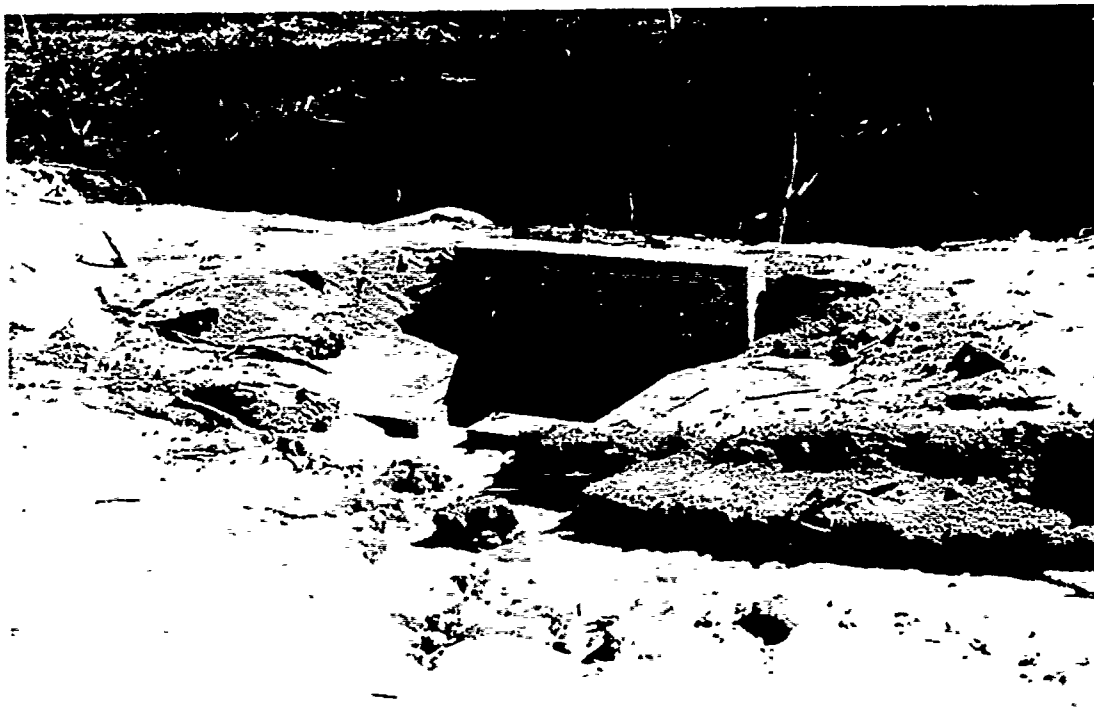
Photo 3-5 Unprotected storm sewer drop inlet on Winslow Way road cut. Sediment flows freely into creek through this.

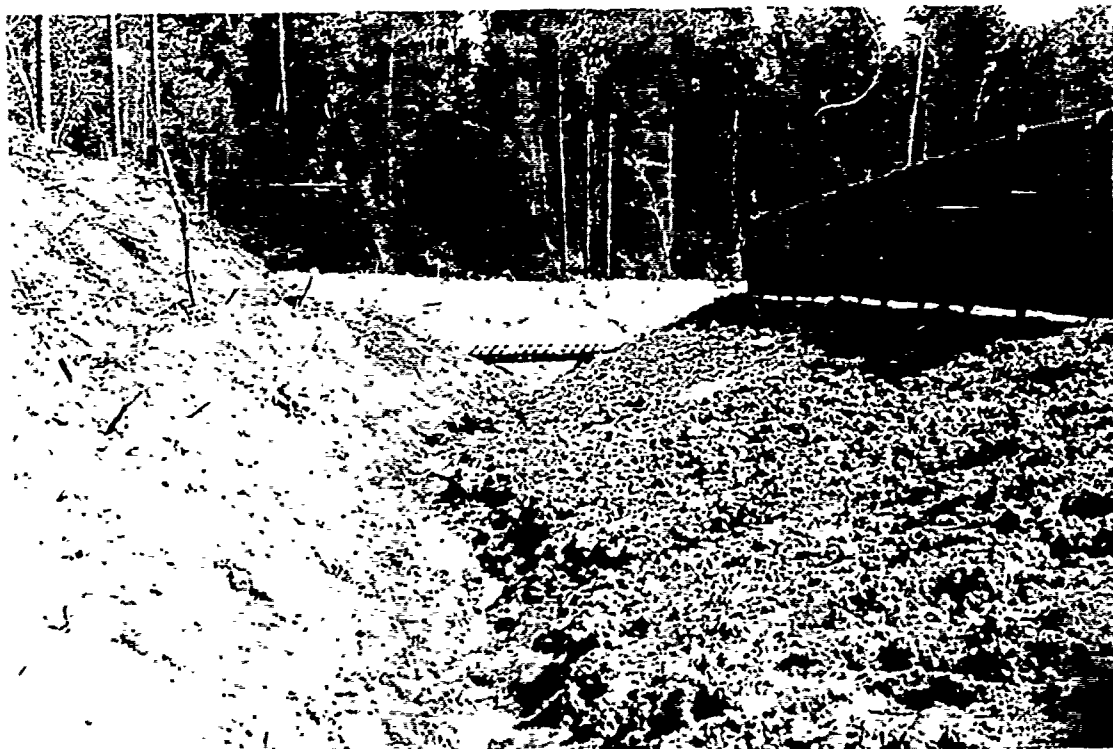
Photo 3-6 Channel cross-section #7 on Moss Field Creek. Notice large rills on channel banks and erosion in channel. August 23, 1990.

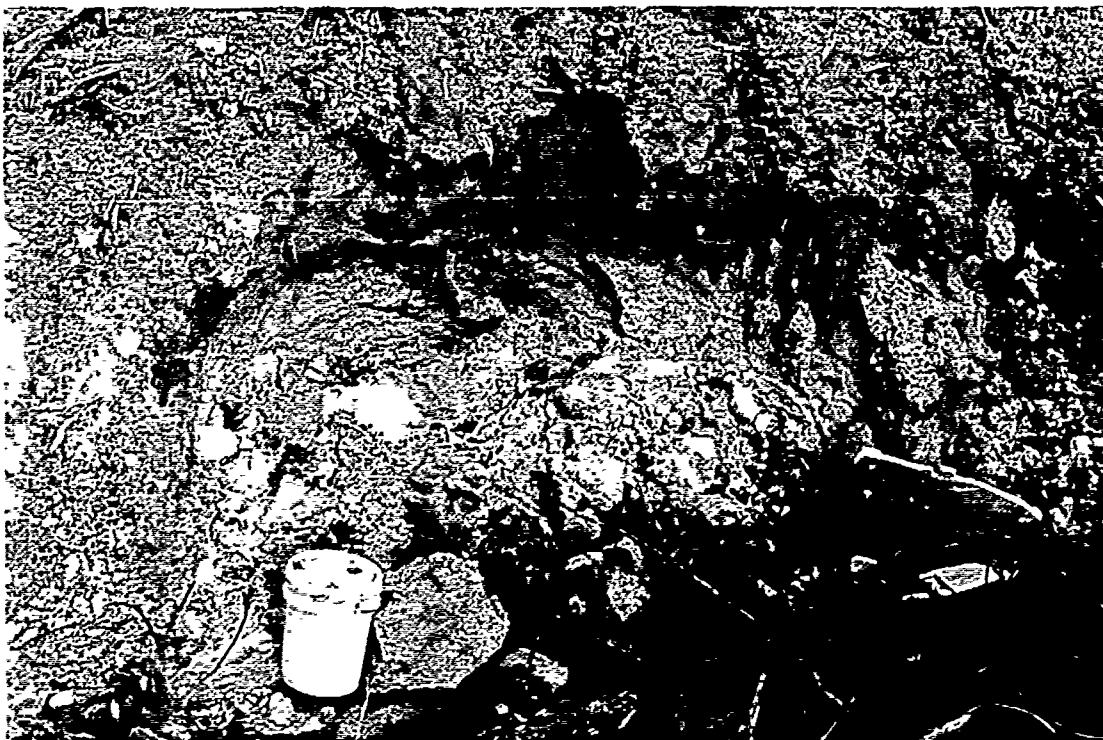
Photo 3-8 Channel slough just below cross-section #8. Note gouging of channel bank caused by channel flow. August 23, 1990.

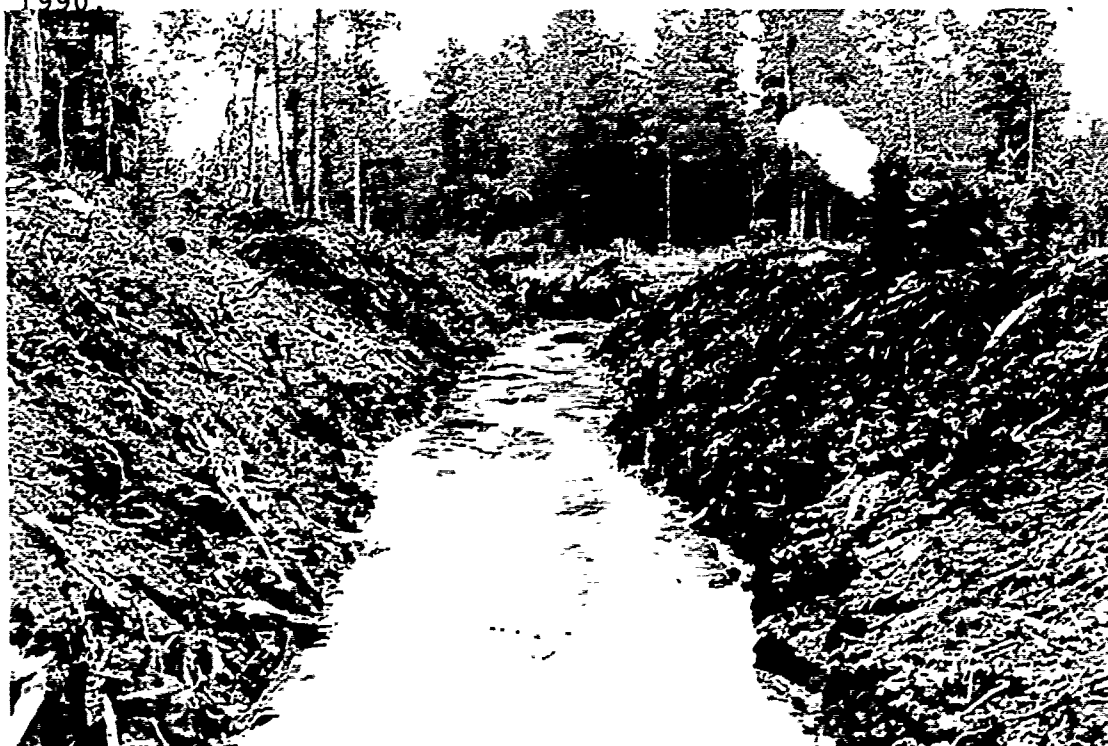
Photo 3-9 Cross-section #9. Sandy channel bottom bed material is approximately 2' thick. Note bare channel banks. August 23, 1990.

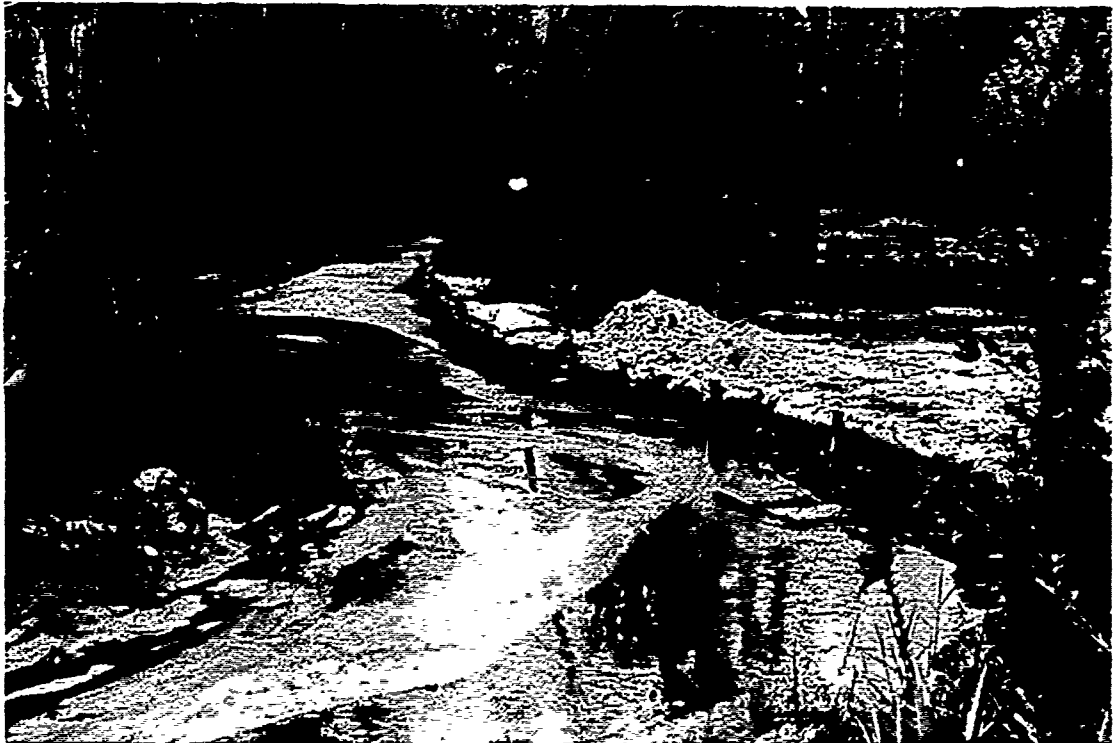
Photo 3-10 View downstream to cross-section #11 on Winslow Creek. Note point bar consisting of coarse sand and gravel. August 23, 1990.

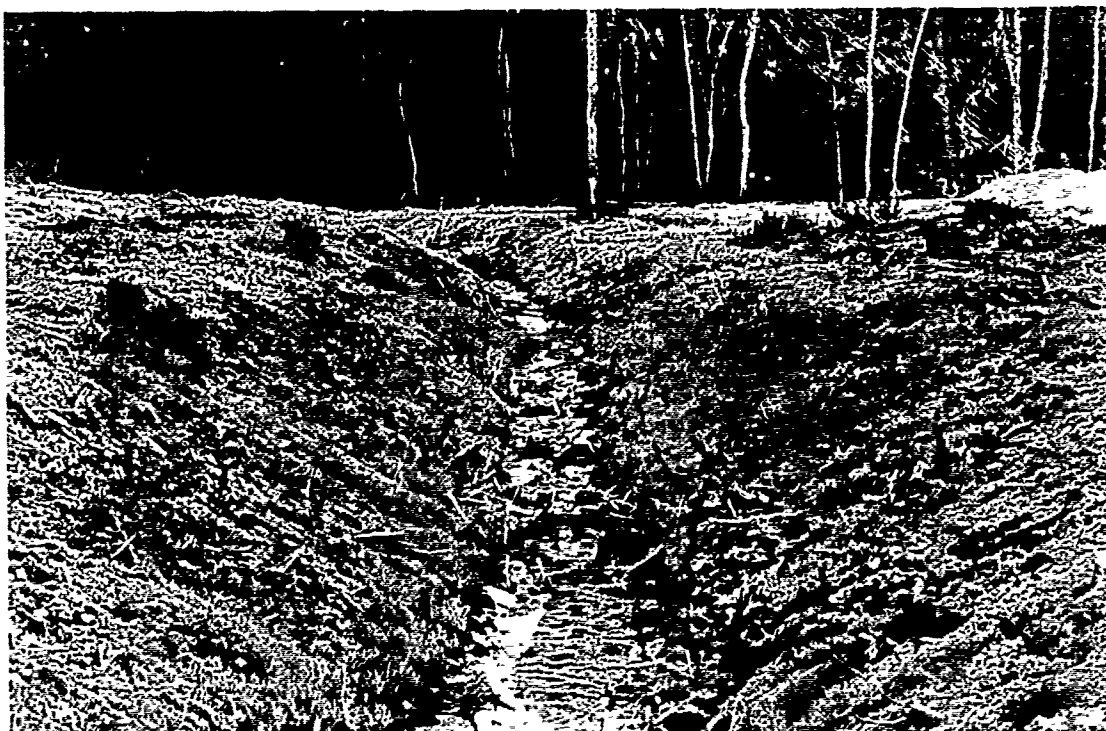
Photo 3-12 View upstream to cross-section #5 on Thornfield Creek. Note growth of grass seed emulsion. August 9, 1990.

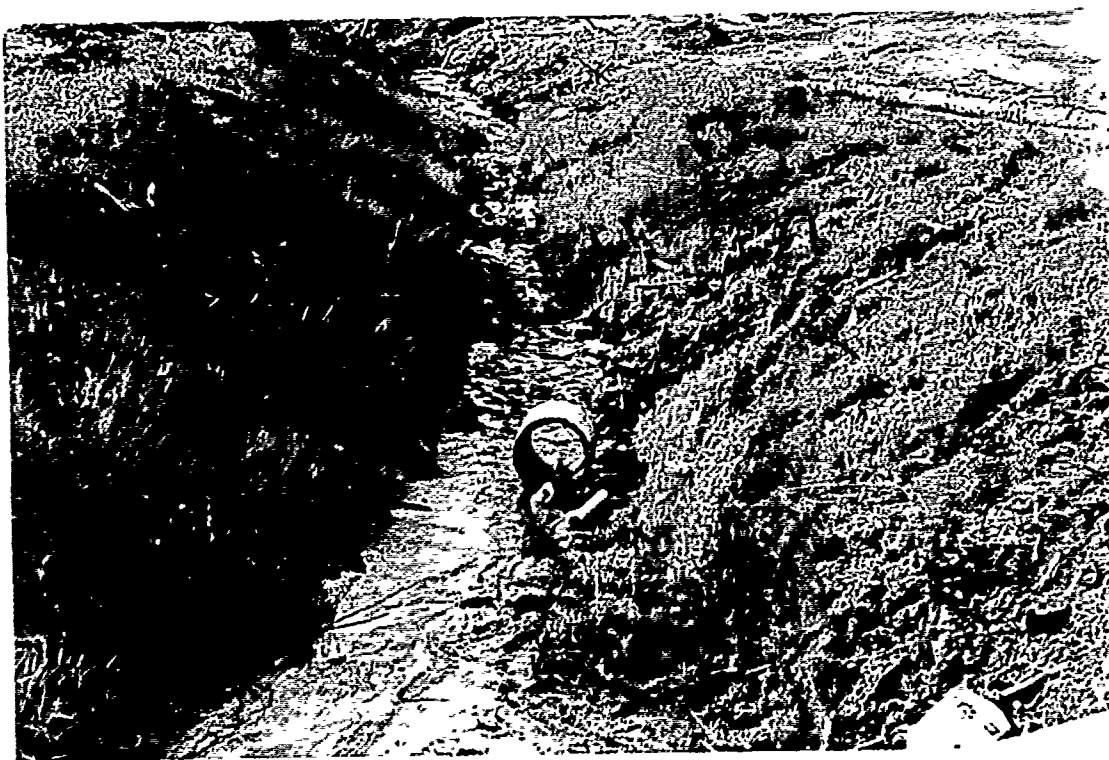
Photo 3-13 View upstream to cross-section #5 on Thornfield Creek. Grass is approximately 12" tall. August 31, 1990.

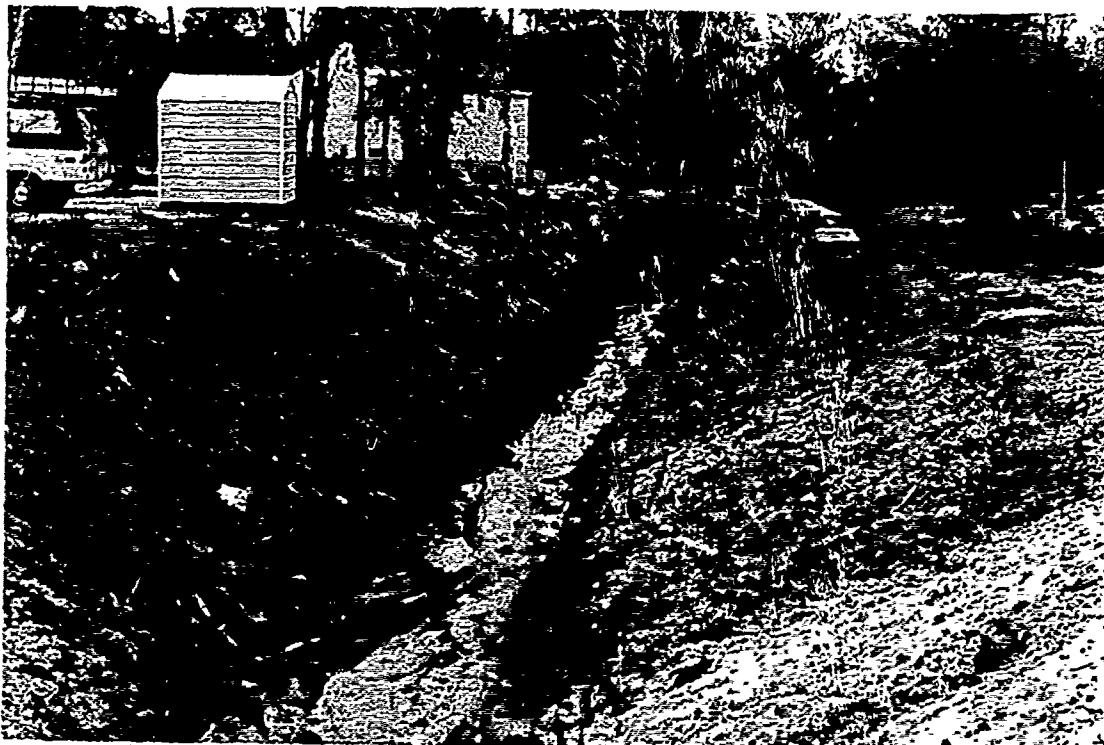
Photo 3-14 View downstream to cross-section #6 on Thornfield Creek near log. Note growth of grass. August 8, 1990.

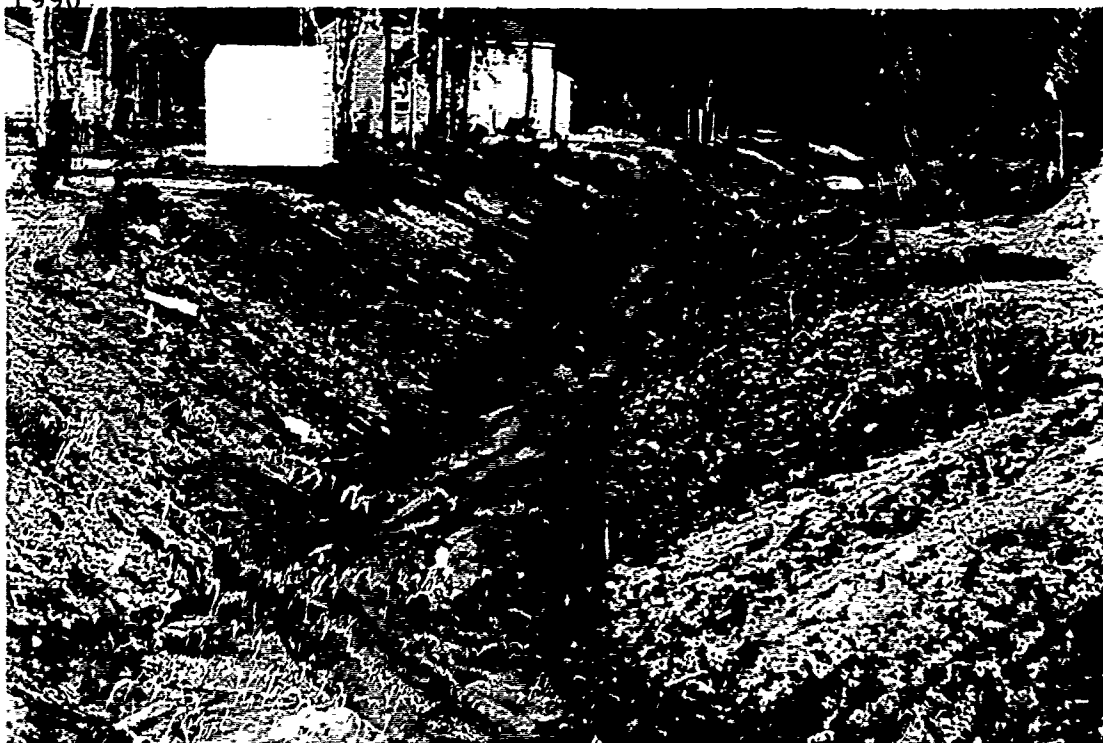
Photo 3-15 View downstream to cross-section #6 on Thornfield Creek near log. Grass at cross-section is stabilizing channel banks. August 31, 1990.
